9033024-01

**DIGITAL MultiSwitch Fast Ethernet Switch
924TXG Release Notes
Version 1.1.1
April 2000**

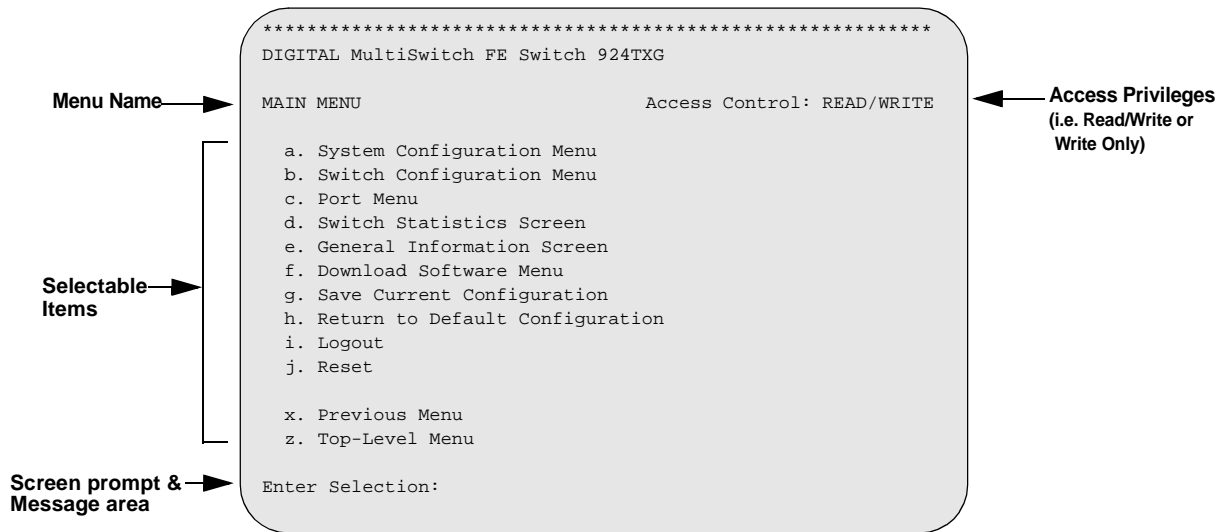
From the module's installation menu, type `f` to view the Main Menu selections as described below.

Selection	Description
System Configuration Menu	Contains commands and parameters that reflect the global configuration of the switch related to management.
Switch Configuration Menu	Provides access to information and parameters affecting the function of the switch, for instance, the movement of packets through the switch. For example, you can configure Forwarding Table, Spanning Tree, and virtual LANs (VLANs).
Port Menu	Shows the configuration of the individual ports on the switch and allows you to modify switch port operation.
Switch Statistics Screen	Presents switch-level and port-level statistics.
General Information Screen	Displays the system software version, switch serial number, base MAC address, system up time and power-up count.
Download Software Menu	Contains parameters and commands for initiating a software download to upgrade the switch operating software.
Save Current Configuration	Saves current switch operating parameters to non-volatile memory.

Return to Default Configuration	Restores switch operating parameters to factory defaults. You must re-set the switch for activate default parameters.
Logout	Logs out of the Telnet interface. Once you logout, you must enter a password before you can access the Telnet interface again. Note: this menu item is only seen from within a Telnet session.
Reset	Performs a software reset of the switch by restarting the system software and reloading all operating parameters.
Previous Menu	Returns you to the previous menu.
Top-Level Menu	Returns you to the top-level menu.
